Technowrap™ Engineered Composite Repairs - 2K HA 48" Main Oil Export Line

Client
Major African Operator
Location
Nigeria

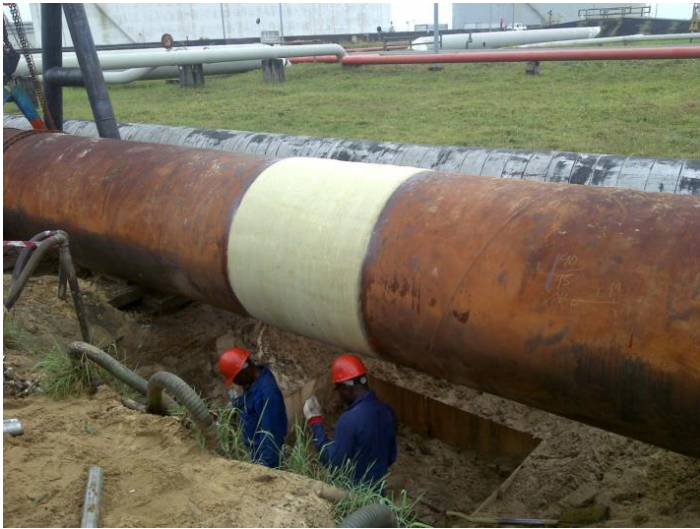
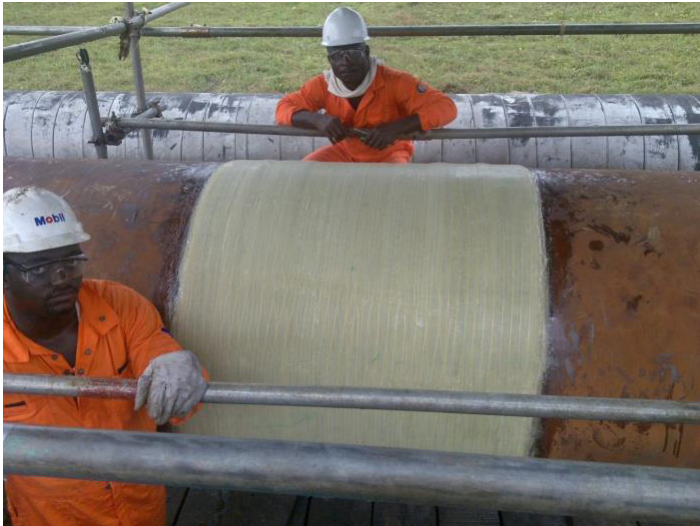
A 48" Main Oil Export line in Africa had sustained patches of external corrosion over a number of areas on the line. The client required an Engineered Composite repair to reinstate the integrity of the line.

The Engineered Design for the Technowrap™ 2K HA repair was performed according to ISO 24817.

Surface preparation to Sa2.5 was carried out by the client to ensure best bond of repair to substrate. The Technowrap™ repair was then installed according to ICR Installation Guidelines.

Existing concrete pipe supports were destroyed and new concrete pipe supports cast and constructed to accommodate repair sites.
